City of Rockland

Downtown Waterfront Marine Infrastructure

Facility Assessment

Rockland, Maine
October 31, 2022

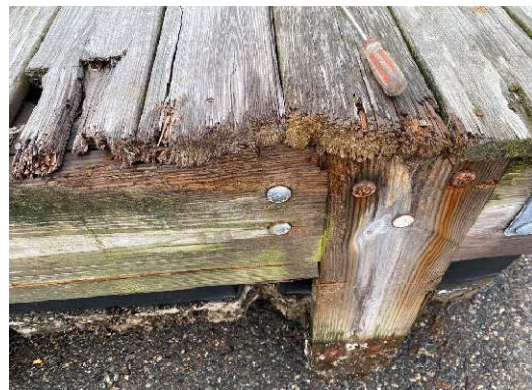
We also noted damage on a number of floats in the areas where they contact the guide piles, some severely (see picture).

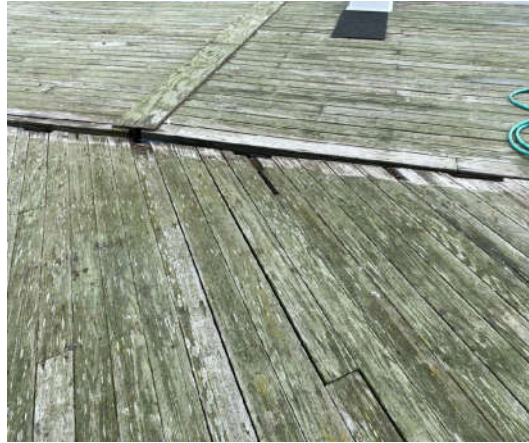
The ends of the deck boards at the gap between floats is ragged in many cases and should be repaired (see picture). The gap dimension between the floats varies in width. The City has plywood transition strips covering the gap on some, but not all, floats. Those seem to work, but could be tripping hazards since they are uneven and worn. Molly Eddy thought that the floats worked better where they had added rigid lumber strips to each float to narrow the gap. This appears to be a better and safer solution.

Replacement of the entire floats does not appear to be necessary, since most of the float structure is sound. Rehabilitation would involve removing the floats from the water, pressure washing as necessary, removing the deck boards, inspecting the timber frame, and replacing anything that is suspect. Replacing fasteners, bolts, and reinstalling the decking. If the boards are otherwise still structurally intact, it is possible to simply turn the boards over and refasten them, giving a virtually new and un-weathered surface. Fasteners should be new stainless steel deck screws or equivalent.

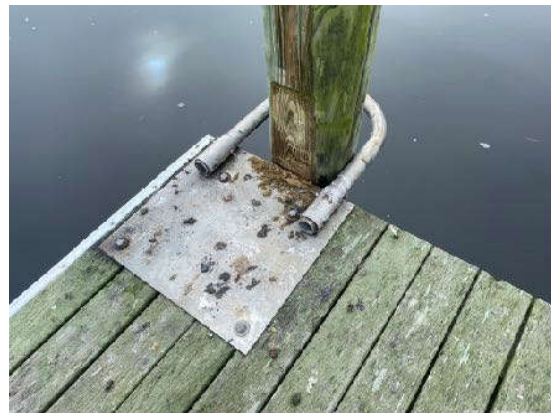
Other guide piles in the system are wearing badly, particularly the southern pine single piles or several that have floats with metal edges or sharp-edged wood members. In those cases, the wear is up to 50% of the original pile, or the float is damaged, or both. The main outer floats on the southwest side have very poor aluminum bent tube collar system. The base plates are shaving the piles, with a substantial pile of sawdust clearly visible during our visit (see picture). Those should be reconfigured and fitted with plastic slide blocks to protect the pile.

Redesign of the float system would offer the opportunity to remedy some of these problem areas; coupled with constant attention thereafter to wear points and reducing stresses in the connections.

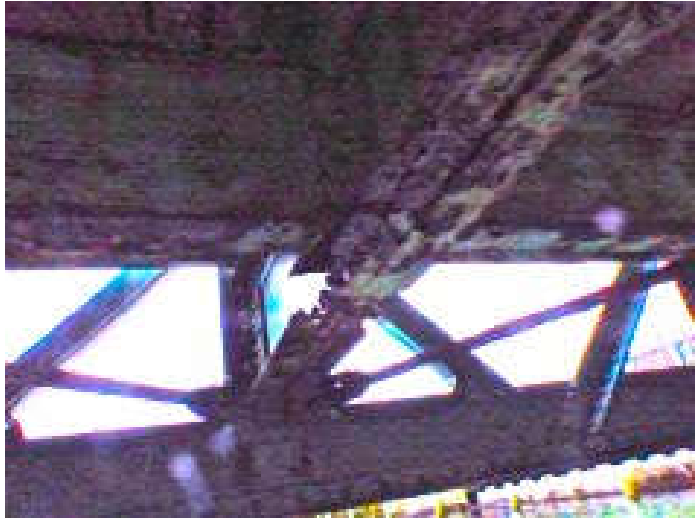
- The trusses consist of 8 equal spaces where there is a vertical member and connections to the X bracing each vertical, there is a cross beam under the deck that spans between the two trusses. This beam is a riveted beam, made up of a vertical web plate and two angles on the top and two angles on the bottom. The overall assembly is 20 1/2" deep x 8 1/2" wide. These span about 13'-2". These beams are heavily corroded and have lost

- significant original capacity, though they were very heavy to start with. Most of the corrosion is on the bottom flanges and is likely caused by splash and spray of salt water. The solid deck overhead would prevent rainwater from washing it off. In some cases, the angles of the bottom flange of the beams have nearly disappeared.

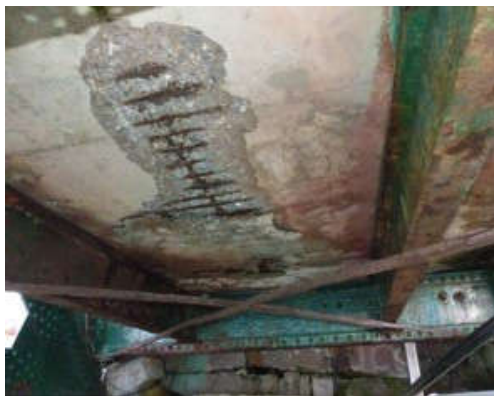
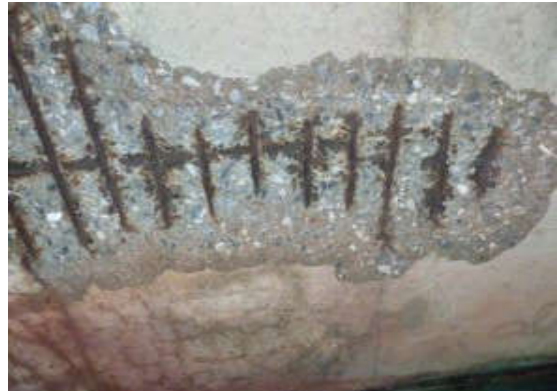
- Concrete deck slab: This appears to be a cast-in place slab that was constructed when the bridge was converted to a pier. The slab is thick and fortified with steel reinforcement. There has been corrosion of the reinforcement on the bottom side that has caused the surface to split and fall away. This exposes the reinforcement to additional corrosion.

Eventually, the concrete must be replaced. The worst area seems to be close to the shore

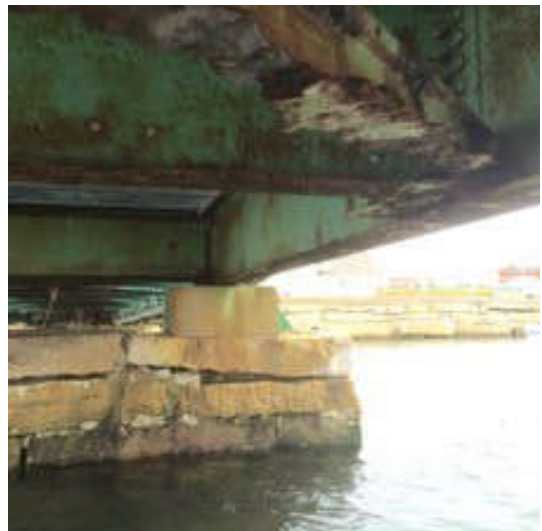
- “The second outer bridge span is a much simpler steel bridge consisting of two steel beams with deck panels that span between them. The beams are rolled steel I-beams 24” deep x 7” wide. These steel beams have corroded on the bottom flanges visibly, mostly on the inside, not visible except from below.

- They have lost some steel cross section of the bottom flanges. Perhaps up to 25% in several places.
- There is one very corroded and bent diagonal that should be replaced. In this span, the concrete slab appears to be a precast slab and would not provide lateral bracing of the span unless it was designed into the connections. It appears that this was part of an original bracing system, there may have been similar diagonals in the other bays that have already fallen away.

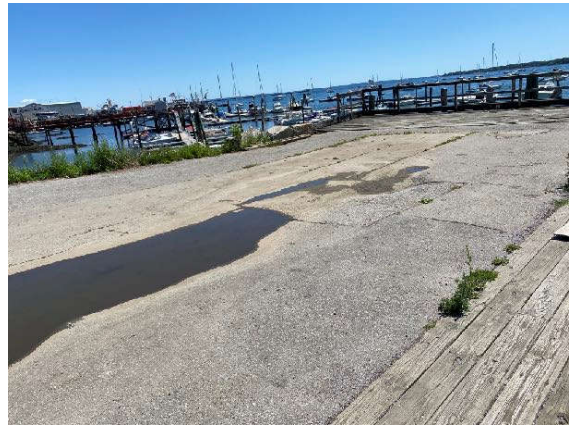
A trouble spot with many filled granite piers, is settlement of the top surface and sinkholes forming in the surface. The cause is that the fine soil materials behind the granite wall, which forms the interior of the pier, is washed out by the cycles of water flowing through the wall, due to tides and storms. The wide joints between stones allow a significant flow of seawater in and out of the structure and the fill material. This flow comes in with a rising tide and out with the falling tide, picks up small particles and grains of soil and stone and carries them out when the tide drops, and water flows out through the cracks. Over the years of the constant flow, the finer soil is slowly removed and a void is formed that will eventually collapse and cause internal settlement and/or a sinkhole will appear on the top surface (see picture).

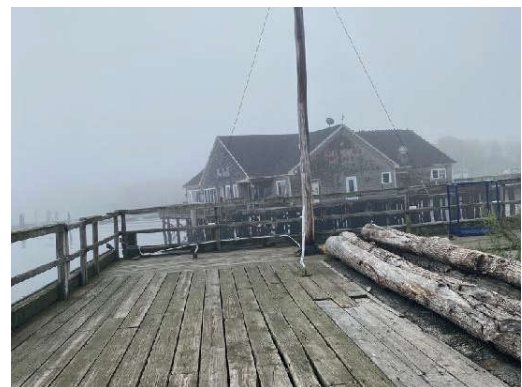
The West side deck leg is 10 feet wide and 246 ft long, and the south side deck leg is 16 ft wide by 38 ft long. The construction is the same on both legs with 3" nominal deck planking and 6x8 and 8x8 curbs. There was some 4" decking, as well, in

places. The outer edge has handrails attached to the inside face of the curbs (see picture).

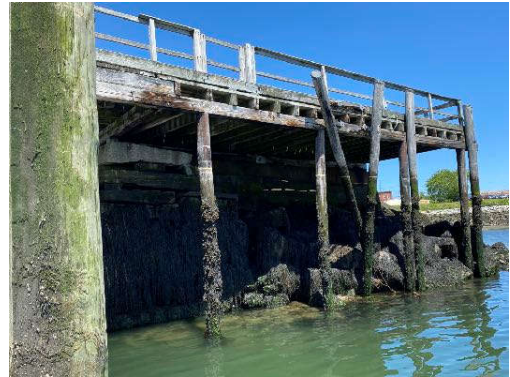
Several older broken fender piles are located on the south side. The piles are fastened to the pile cap. One of the piles is broken free at the top and another is dangling from one bolt (see picture).

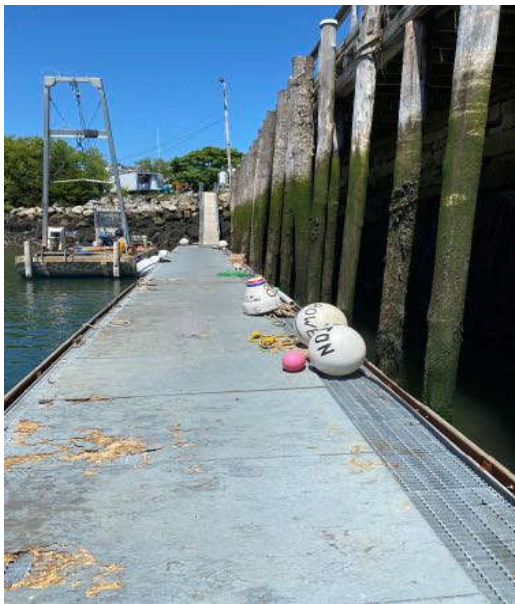
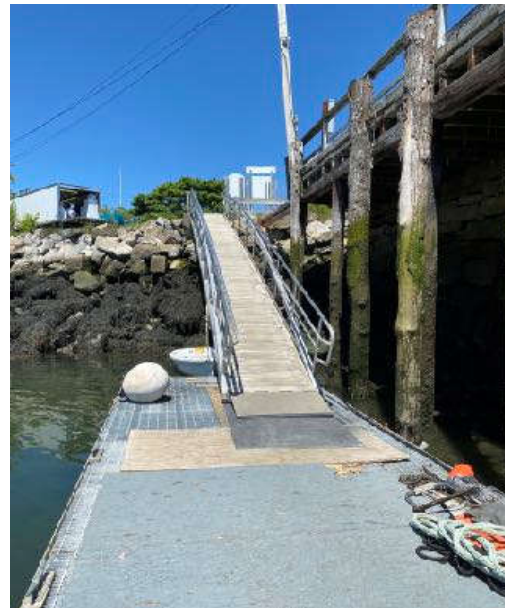
The existing aluminum gangway appears to be fairly new and meets ADA standards except for length (see picture). The existing abutment is lower than the anticipated deck level for sea level rise, but could perhaps be designed with a short on-grade ramp or steps when the grades are changed in that area. Or it may be easier to rebuild the abutment as part of the pier reconstruction.

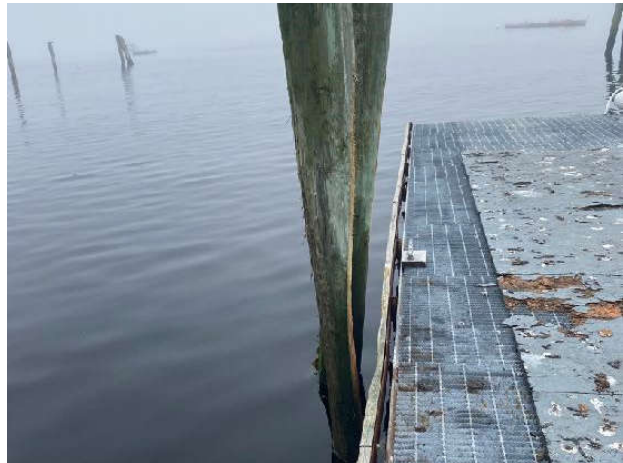
These floats are recycled, obsolete aquaculture cage components used in the Downeast area for Atlantic Salmon operations some 30 years ago. They seem to be satisfactory for their purpose at Middle Pier. They consist of galvanized steel frames with welded steel grating with serrated bars, supported by plastic float drums. The top surface has been covered with painted Oriented Strand Board (OSB) panels, that needs to be renewed. Pressure treated plywood would be preferable to OSB. The outer edges of the original fish cages did not have rub strips or fendering so plain steel bars were welded to the edges. These are beat up and corroded and should be replaced. The steel edges need to be protected since they are causing chafe to the guide piles.

These floats could be reused in the redevelopment of the pier. They should be removed from the water and reconditioned as necessary. This would include inspection and repairs of the metal grating, hinges, edge fendering and flotation. Replacement float drums may be needed if the existing floats are found to be punctured or damaged.
