City of Rockland

Downtown Waterfront Marine Infrastructure

Facility Assessment

Rockland, Maine
October 31, 2022

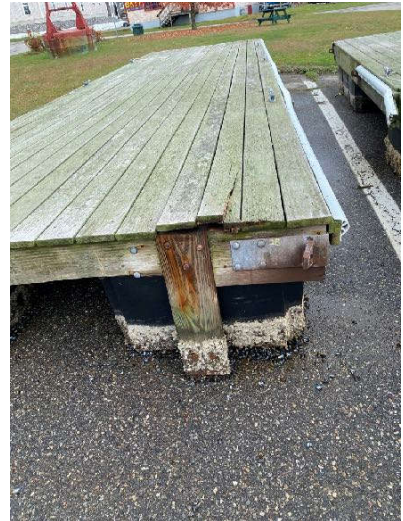
mapping of the float positions that allows the floats to be returned in the spring to the same spot and to fit into the guide pile system. At this time, it appears that a more proactive program for replacement or rehabilitation would be desirable, as the City is not keeping up with the deterioration of the floats. In particular this year, a large number of the floats out of the water are missing the skids (see picture), which have failed from decay of submerged wood and corrosion of the associated bolts.

- All floats are unpainted
- Various types and configurations of collars and anti-friction devices are present, but some have no provision to alleviate chafe
- The floats are of multiple age groups
- The older floats are noticeably more deteriorated, primarily in the skids- both the horizontal skid beams, and skid vertical struts

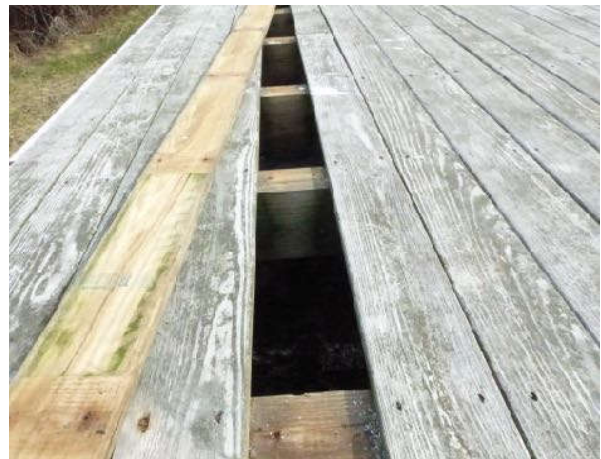
We would recommend that you consider flipping the boards over as a part of a general rehabilitation. The top surface of the deck boards is weathered on all of the floats, but it can be seen that the bottom surface of the boards is like new (see picture). The weathering is not usually significant for weakening the boards, but harbor dirt and bird droppings make cleaning difficult, as well as the poor appearance. The 5/4" decking seemed generally in good condition in 2016, but in 2022 seems to be more weathered and deteriorated, especially on some of the older floats. Some floats have had partial replacements of the deck boards and our inspection did not show anything that is generally unsafe, though continuous inspection and maintenance of decking will be necessary.

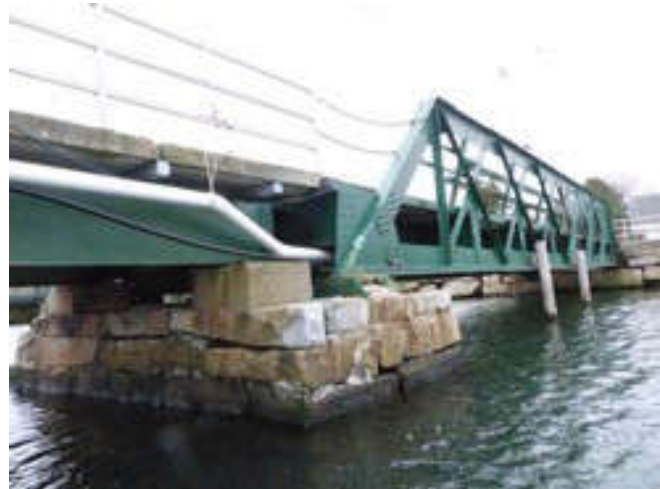
- Trusses: The Bridge consists of two riveted steel trusses 8ft deep x 65ft long, bearing on heavy-cast steel or iron bearings, and supported on the granite walls at each end. The trusses are the main load-carrying elements and have been well painted and cared for. There seem to be few signs of corrosion except a few localized dents and some light corrosion on the bottom members near the ends. These trusses have escaped the corrosion seen on the other members underneath, perhaps because they are exposed to the rain, which would wash off any salt spray deposits.

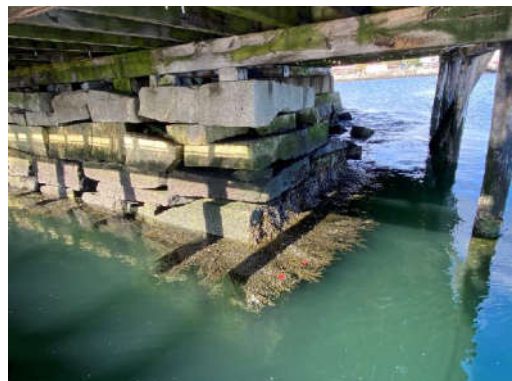
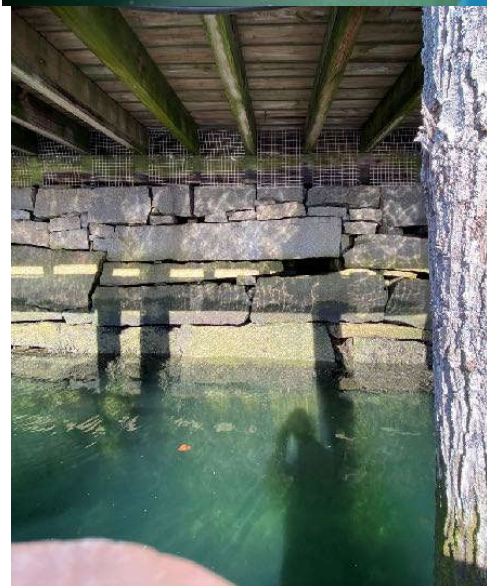
At the southwest corner, the pier timber deck is supported on a large cantilevered stone. When rebuilt, this area needs attention to reconfigure the timber deck for support further into the main mass of the wall.

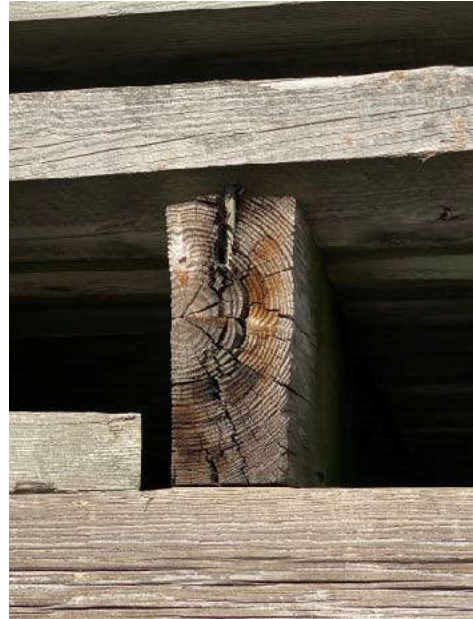
There is a general weathered and shabby appearance, particularly the handrails, which are in very poor repair. Many places where the joists are visible, there are splits from the large diameter spikes used to fasten the deck planks, particularly near the ends (see picture below). The splitting is significant to the point that it has released the grip on the spikes holding the planks, so some of the planking has become detached and lifted at one end and creates a tripping hazard.

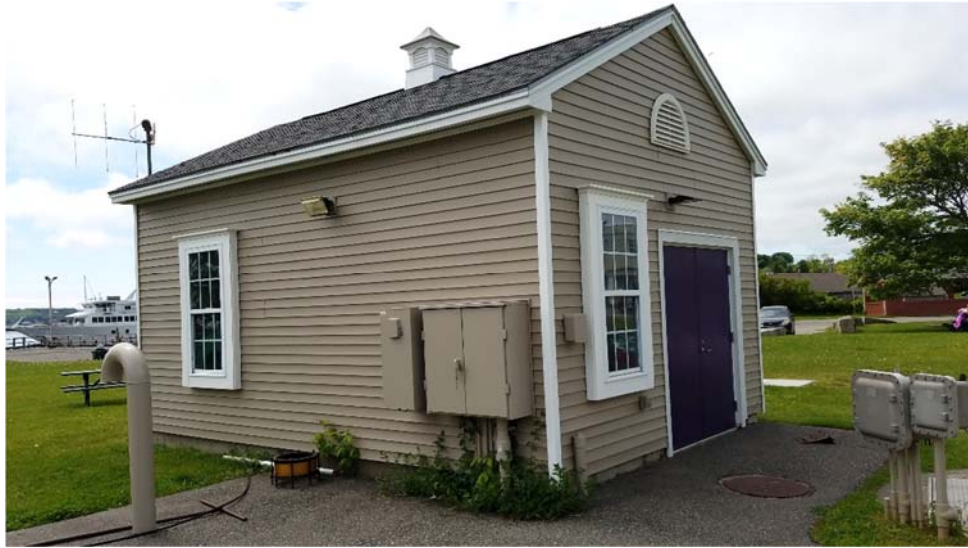
Photograph No. 19:

Site structures include a sewage pump station and lobster pavilion for cooking during events. The pump station appears to be a wood-framed structure on stem wall with gable type roof (**Photographs 19 & 20**). The building has four (4) windows, one main access door, and a large rear louver. Exterior cover appears to be vinyl siding and asphalt shingle roofing. What appears to be a concrete slab on grade exists at the north side of the building to provide access to the door and the associated sewer well. The top of grade at the building is roughly 15 feet with a finish floor elevation (FFE) approximately 8 inches above the current grade.

View of sewer pump station and wet well cover.

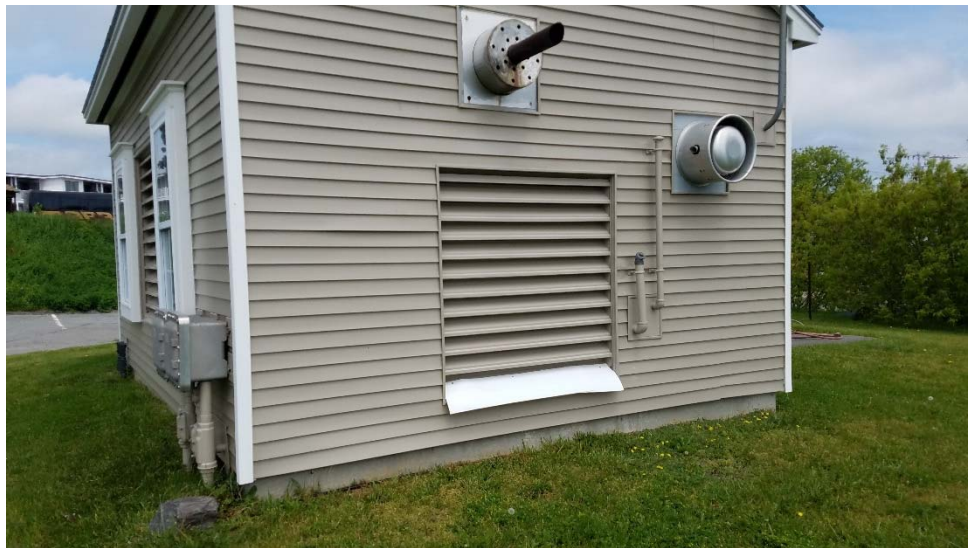
Photograph No. 20:

Rear view of sewer pump station building.

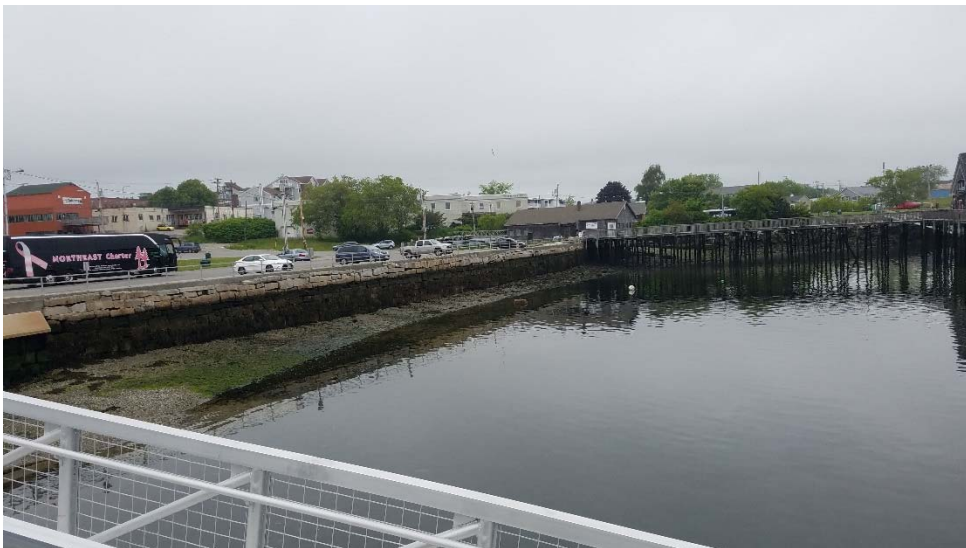
Photograph No. 26:

View of sea wall at harbor park near Harbormaster's office.
